Manhole Inspection Summary

Manhole # S13AA1014MH

Insp Date: **1/26/09 10:28 AM**

Location Address: **3733 SPRINHILL AVE**

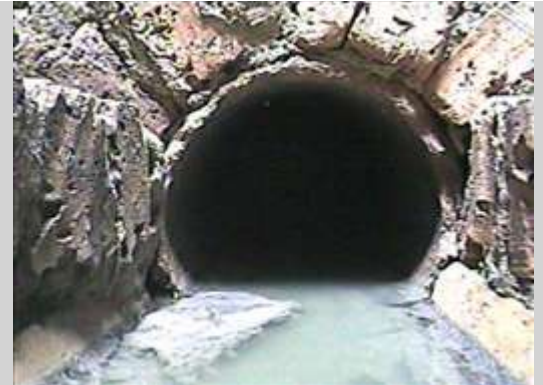
12 O'Clock Outflow

8 in. Circular Gravity Sewer
Pipe Out @ 12 O'Clock

Pipe Height: (in.) Direct
Pipe Material: **Clay** ☐ Pipe Lined
Invert Depth: **7.24** (ft.) Flow Characteristics: **Slow**
Deposits: ☒ None ☐ Mud ☐ Sludge ☐ Debris ☐ Grease
Silt Depth: (in.) Deposits Extent:
Infiltration: **None** Pipe Seal Cond: **Unknown**
